Manhole Inspection Summary

Manhole # S09MM_001MH

Insp Date: **8/20/07 4:27 PM**

Location Address: **DENISON AVE**

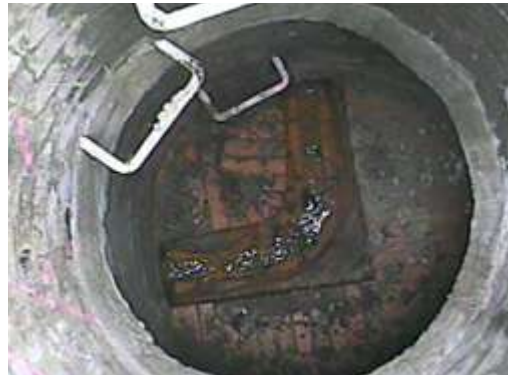
Top View

DEBRIS ON BENCH

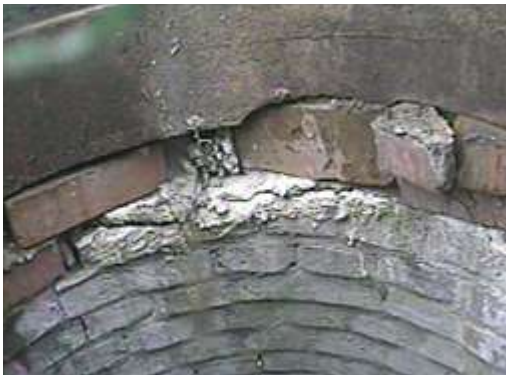
Defect 1

Condition: ☐ Sound ☒ **Cracked** ☐ Root Intrusion ☐ Loose Brick ☒ **Deteriorated**

CRACKED AND DETERIORATED
FRAME ADJUSTMENT

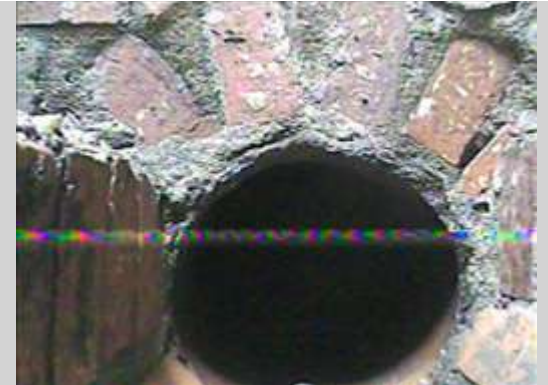
12 O'Clock Outflow

8 in. Circular Gravity Sewer
Pipe Out @ 12 O'Clock

Pipe Height: (in.) Direct
Pipe Material: **Clay** ☐ Pipe Lined
Invert Depth: **7.41** (ft.) Flow Characteristics: **Slow**
Deposits: ☒ None ☐ Mud ☐ Sludge ☐ Debris ☐ Grease
Silt Depth: (in.) Deposits Extent:
Infiltration: **None** Pipe Seal Cond: **Cracked**

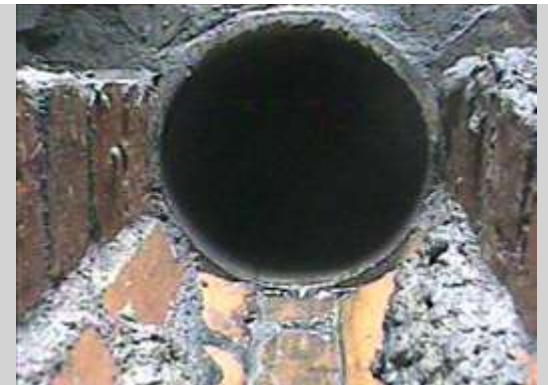
9 O'Clock Inflow

8 in. Circular Gravity Sewer
Pipe In @ 9 O'Clock

Pipe Height: (in.) Direct
Pipe Material: **Clay** ☐ Pipe Lined
Invert Depth: **7.00** (ft.) Flow Characteristics: **Slow**
Deposits: ☒ None ☐ Mud ☐ Sludge ☐ Debris ☐ Grease
Silt Depth: (in.) Deposits Extent:
Infiltration: **None** Pipe Seal Cond: **Sound**

Connects To: **Stub connection / abandoned**
